Compliance Report

For the Period: January 1, 2025 through June 30, 2025

Boston Water and Sewer Commission

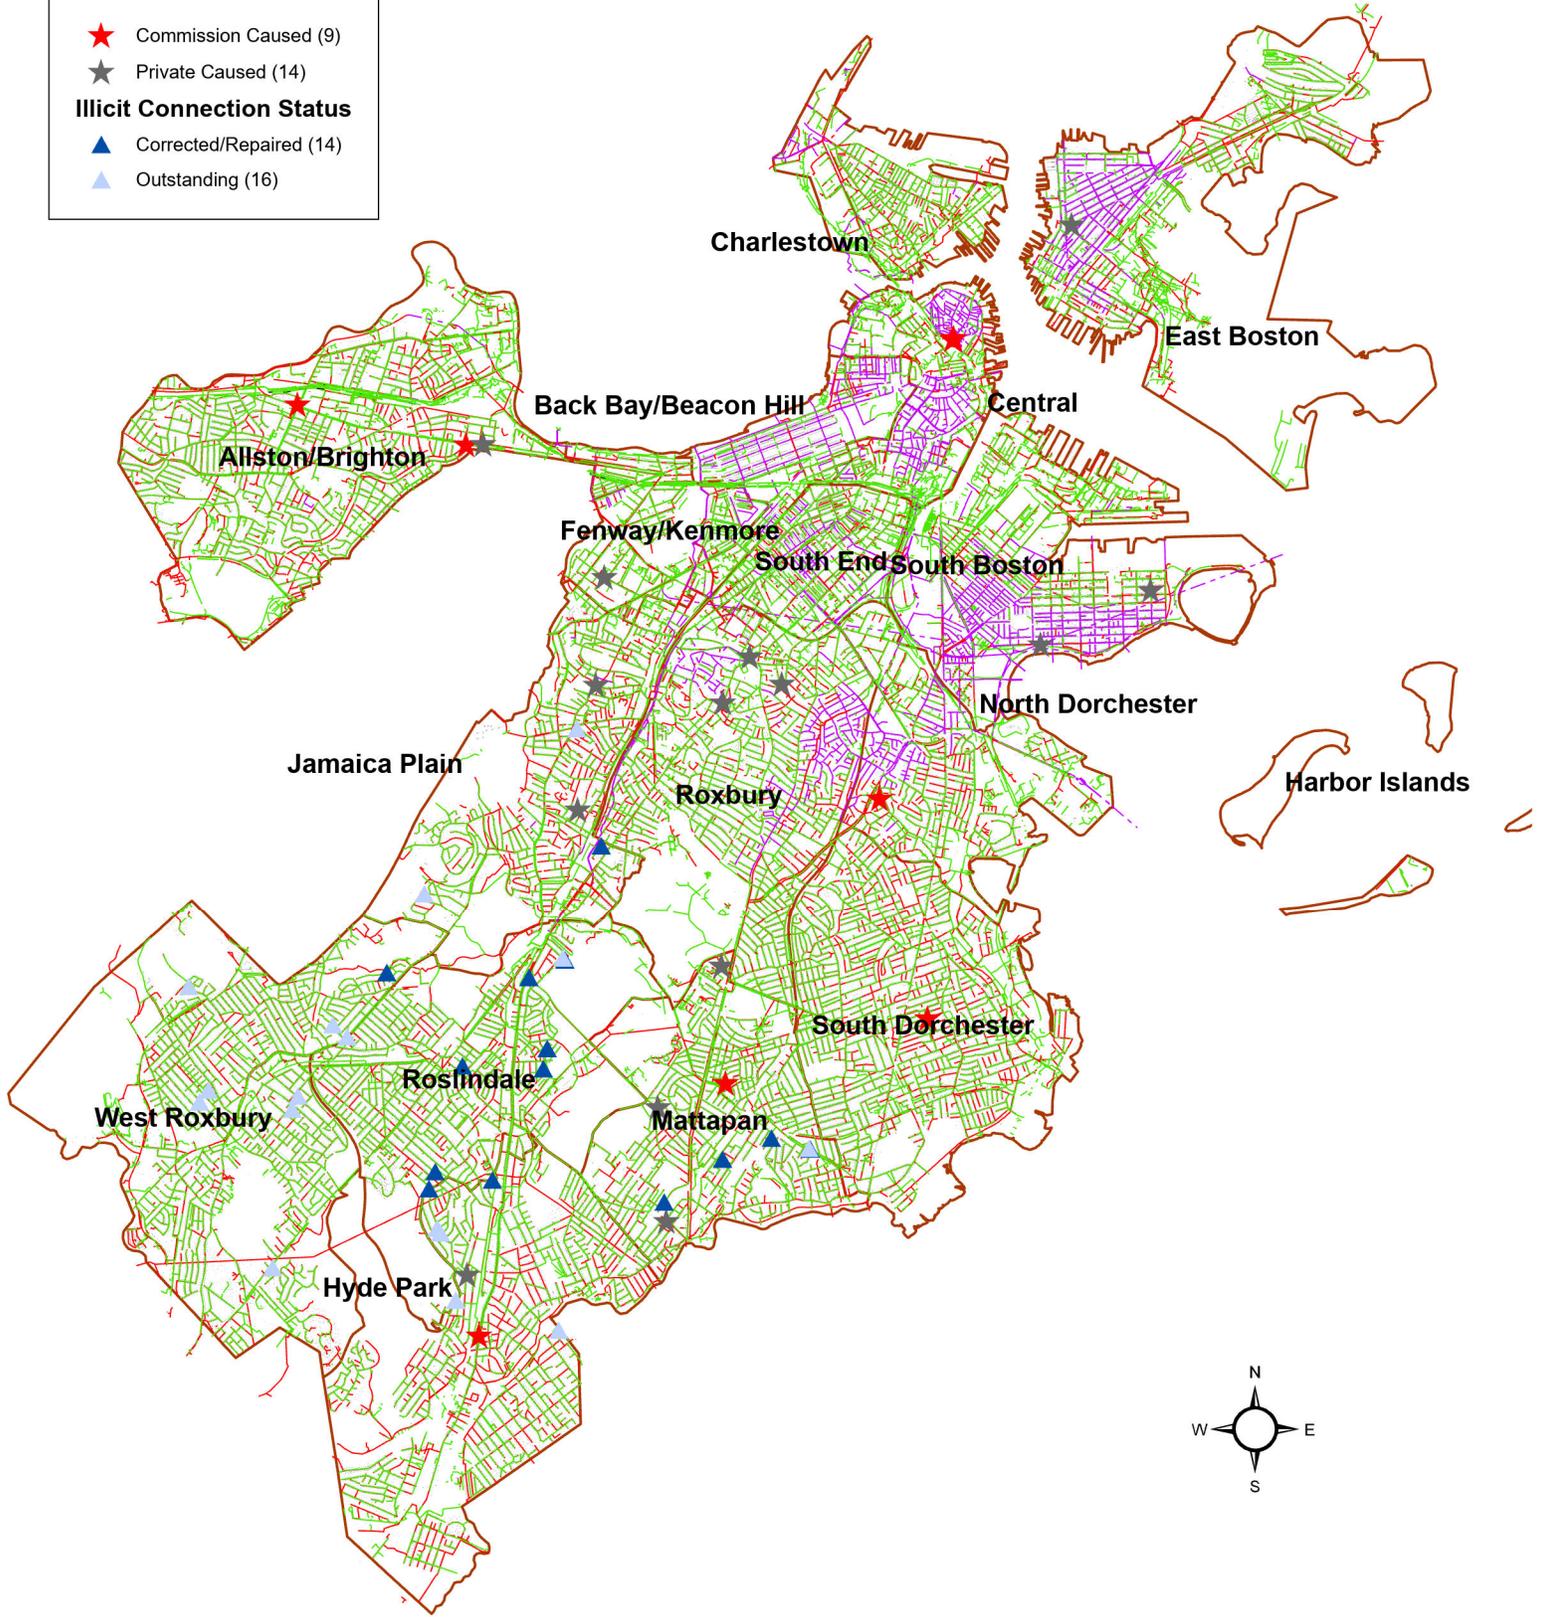
FIGURE 1
VERIFIED ILLICIT DISCHARGES AND SEWER SYSTEM OVERFLOWS DURING REPORTING PERIOD
01/01/25 - 06/31/25

- SSO Work Orders**
- ★ Commission Caused (9)
 - ★ Private Caused (14)
- Illicit Connection Status**
- ▲ Corrected/Repaired (14)
 - ▲ Outstanding (16)

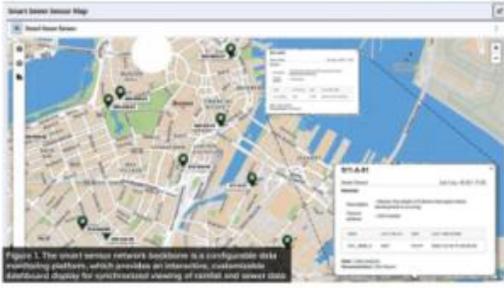
Figure 1. The smart sewer network backbone is a configurable data monitoring platform, which provides an interactive, customizable dashboard display for continuous viewing of real-time sewer data.

The main dashboard (Figure 1) displays monitoring points on a geographic information system (GIS) map. Display markers are color-coded according to the real-time level. Green shows when a sewer is operating at normal levels, while yellow, orange, red, and purple indicate varying levels of system overcharge. Each monitoring site was reviewed to determine water levels based on historical average operating level and overflow risk, relative to elevation of nearby outfalls, basements, etc.
