**Boston Water and Sewer Commission**

**CSO Monitoring Report  
2019**

**CSO Monitoring Report  
For the period from January 1 to December 31, 2019**

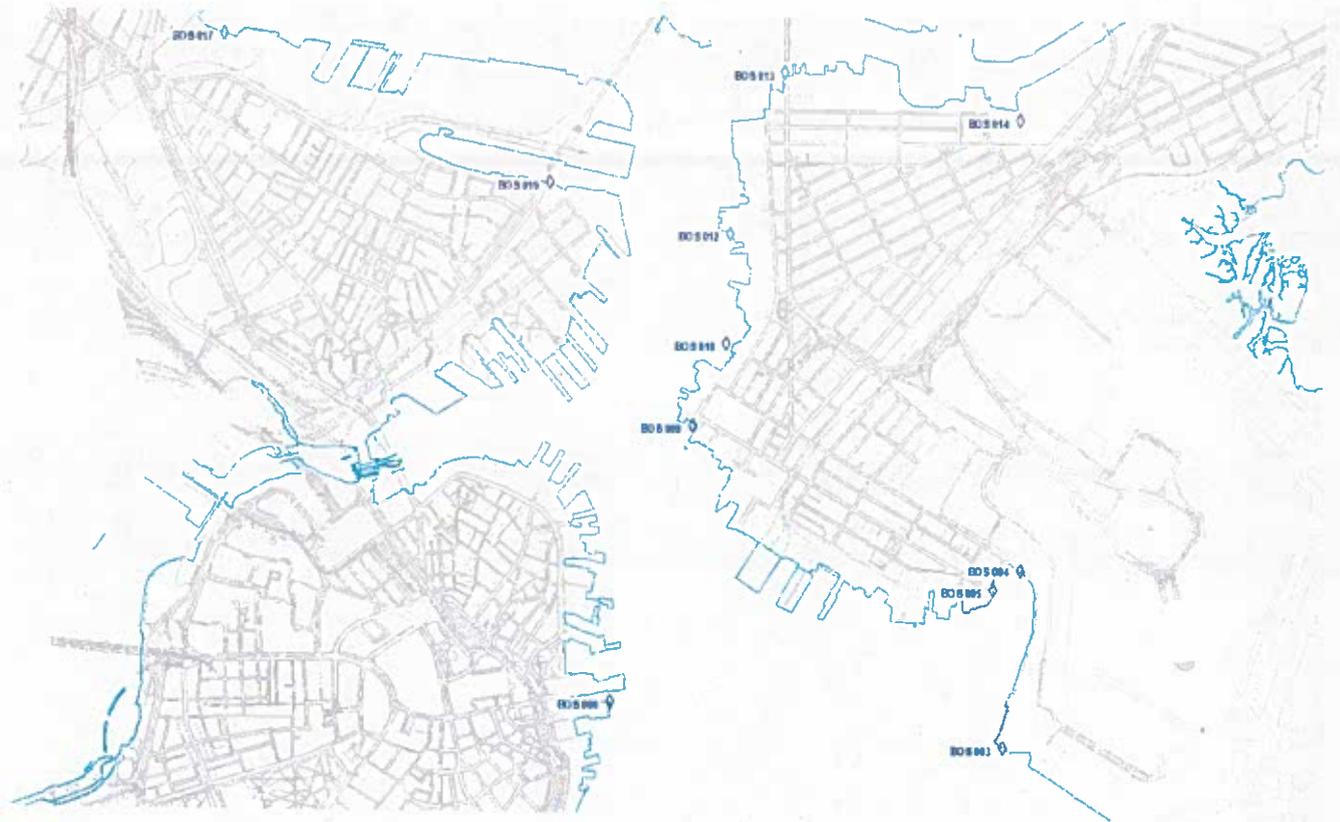
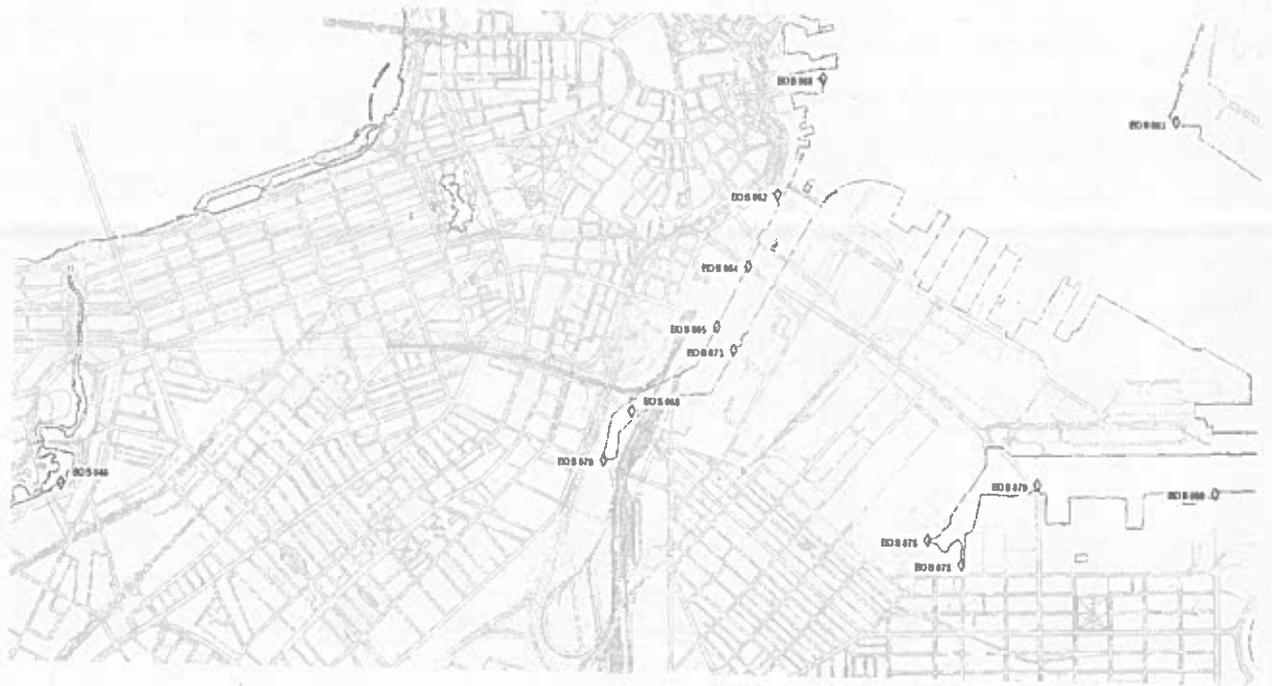
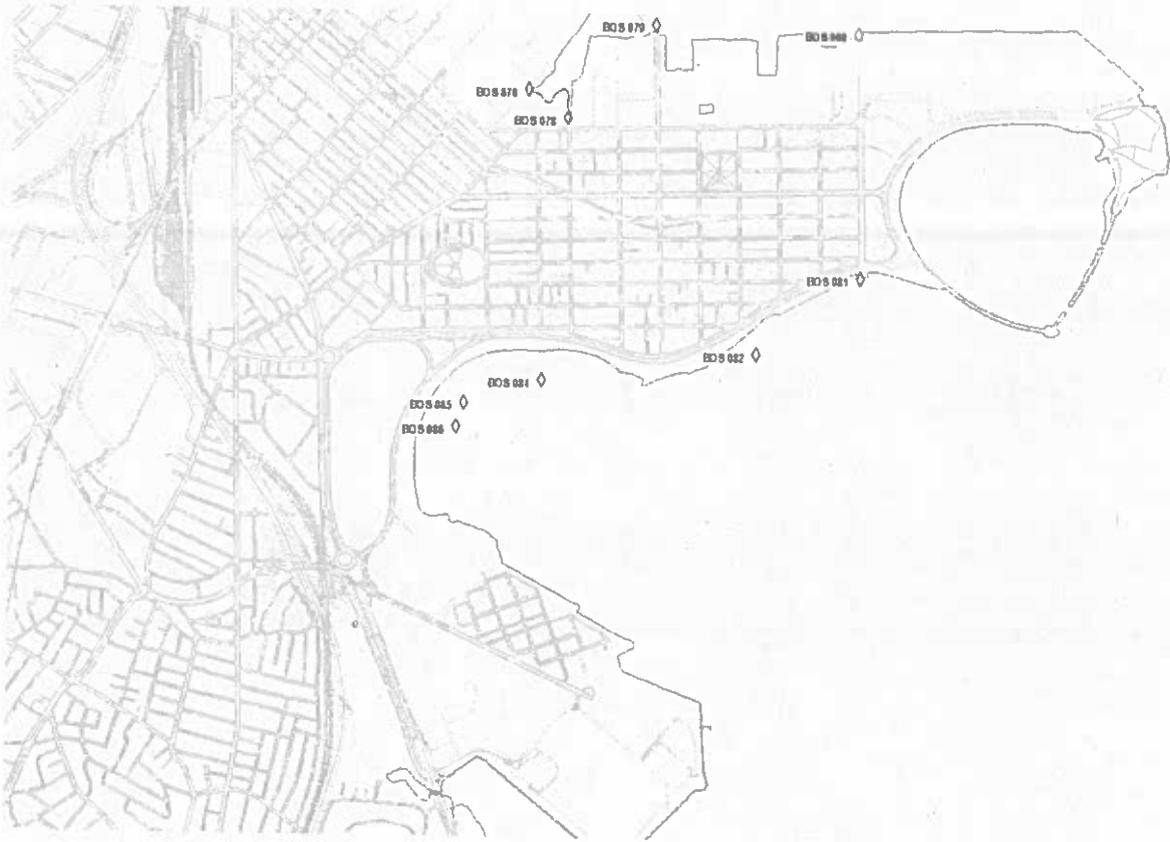
**Figure 1A: CSO Outfalls 2019**

**Figure 1B: CSO Outfalls 2019**

**Figure 1C: CSO Outfalls 2019**

The 37 permitted CSO outfall locations are shown in Figures 1A, 1B and 1C. These locations are also listed in Table 1. Eight (8) of these CSOs are inactive or unable to discharge. BOS 083, included in this group, was routed by the MWRA as part of their North Dorchester Bay CSO Storage Tunnel project (NDB Tunnel). The remaining 29 CSOs are active and can discharge into Boston Harbor, NDB Tunnel or the Muddy River. Five (5) of these CSOs are upstream of the MWRA's NDB Tunnel which discharges only during very large storms, a 25-year storm or larger.

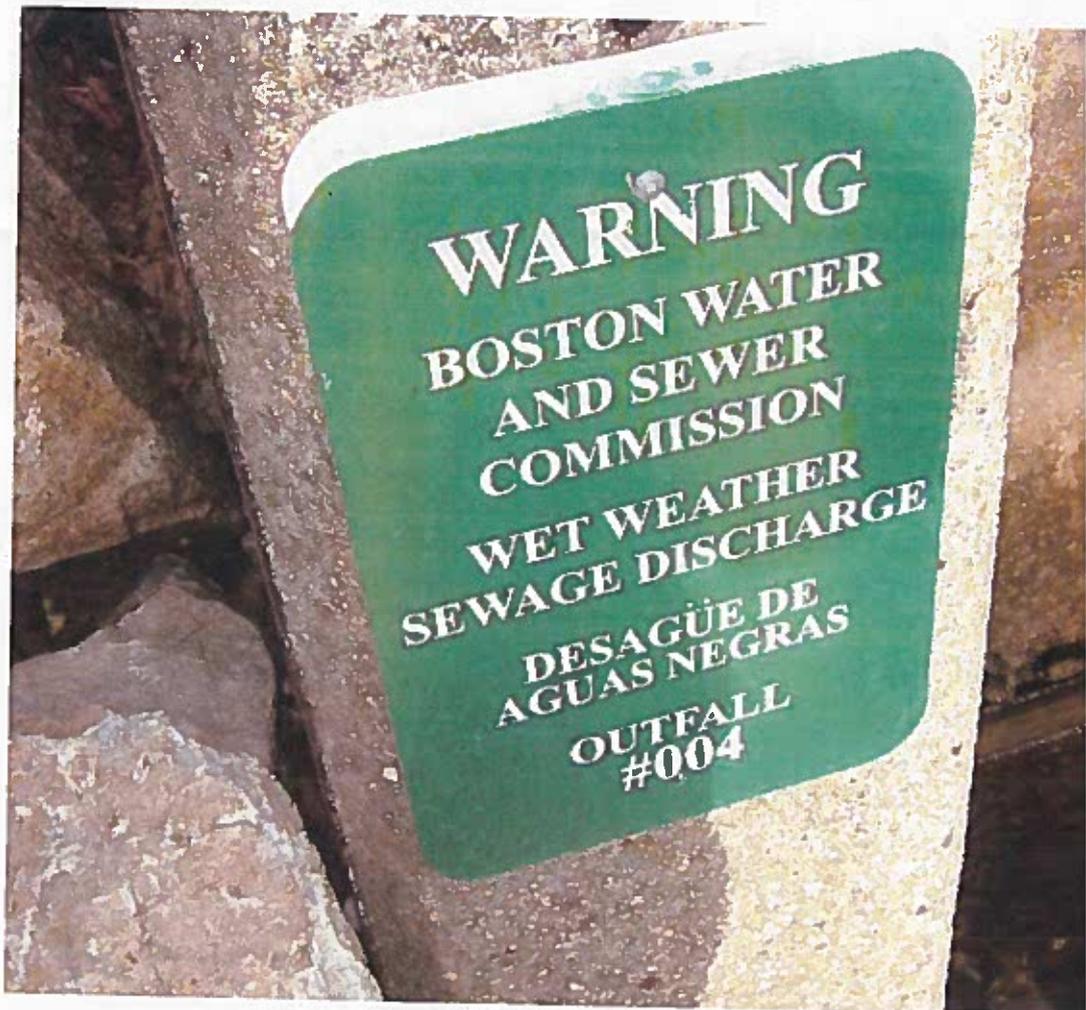
**Figure 2: Example of a sign identifying a CSO discharge point**

In compliance with the Nine Minimum Controls, the Commission maintains signs that indicate CSO outfalls and keeps the community abreast of its sewer management actions. An example of a sign identifying outfall BOS 004 in East Boston is shown in Figure 2.

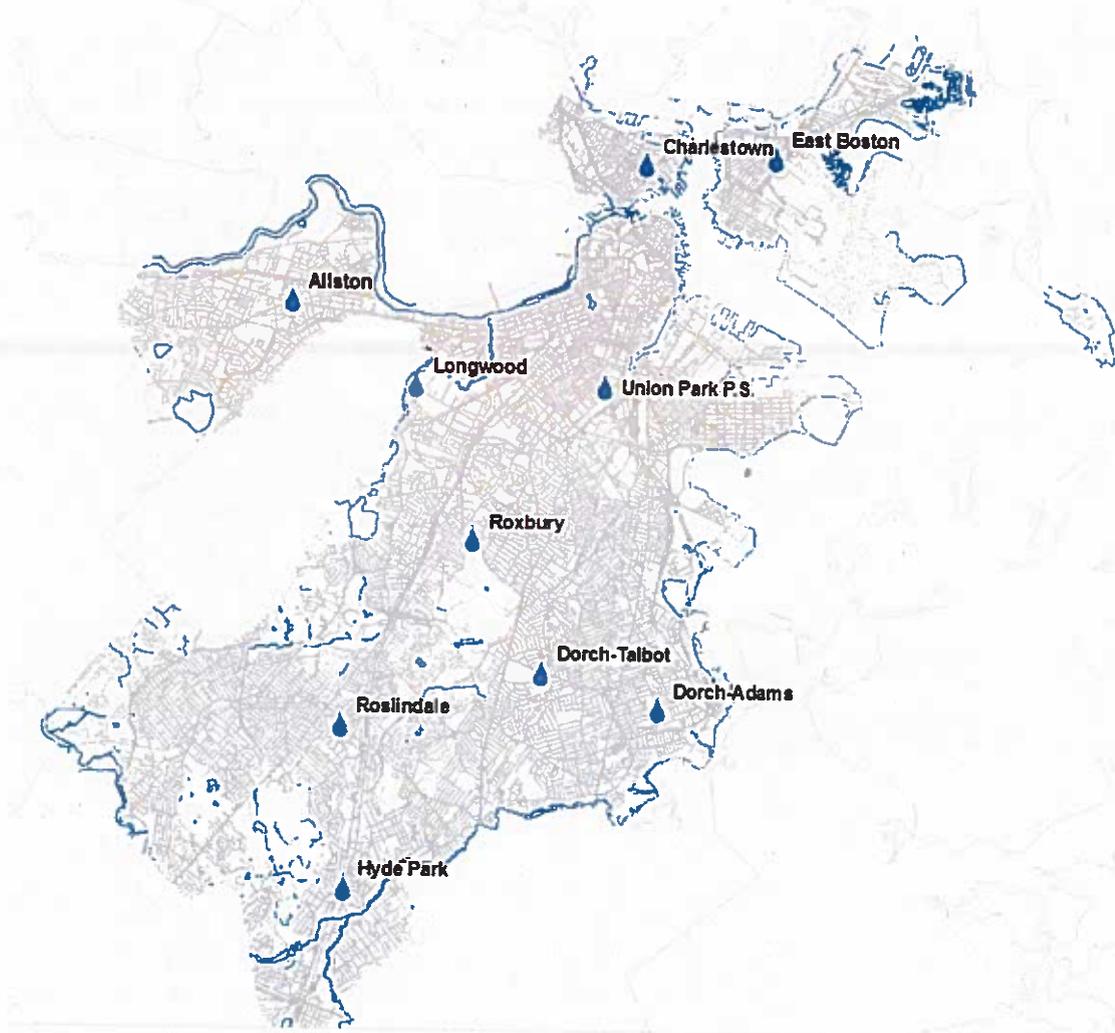
**Figure 3 – BWSC Rain Gage Locations**

Over the last 10 years, patterns exist in the rainfall distributions; some locations consistently have more rainfall than others. Generally, the Commission's gages record more rainfall than Logan Airport. The Commission's ten rain gages are shown on Figure 3 on the following page.

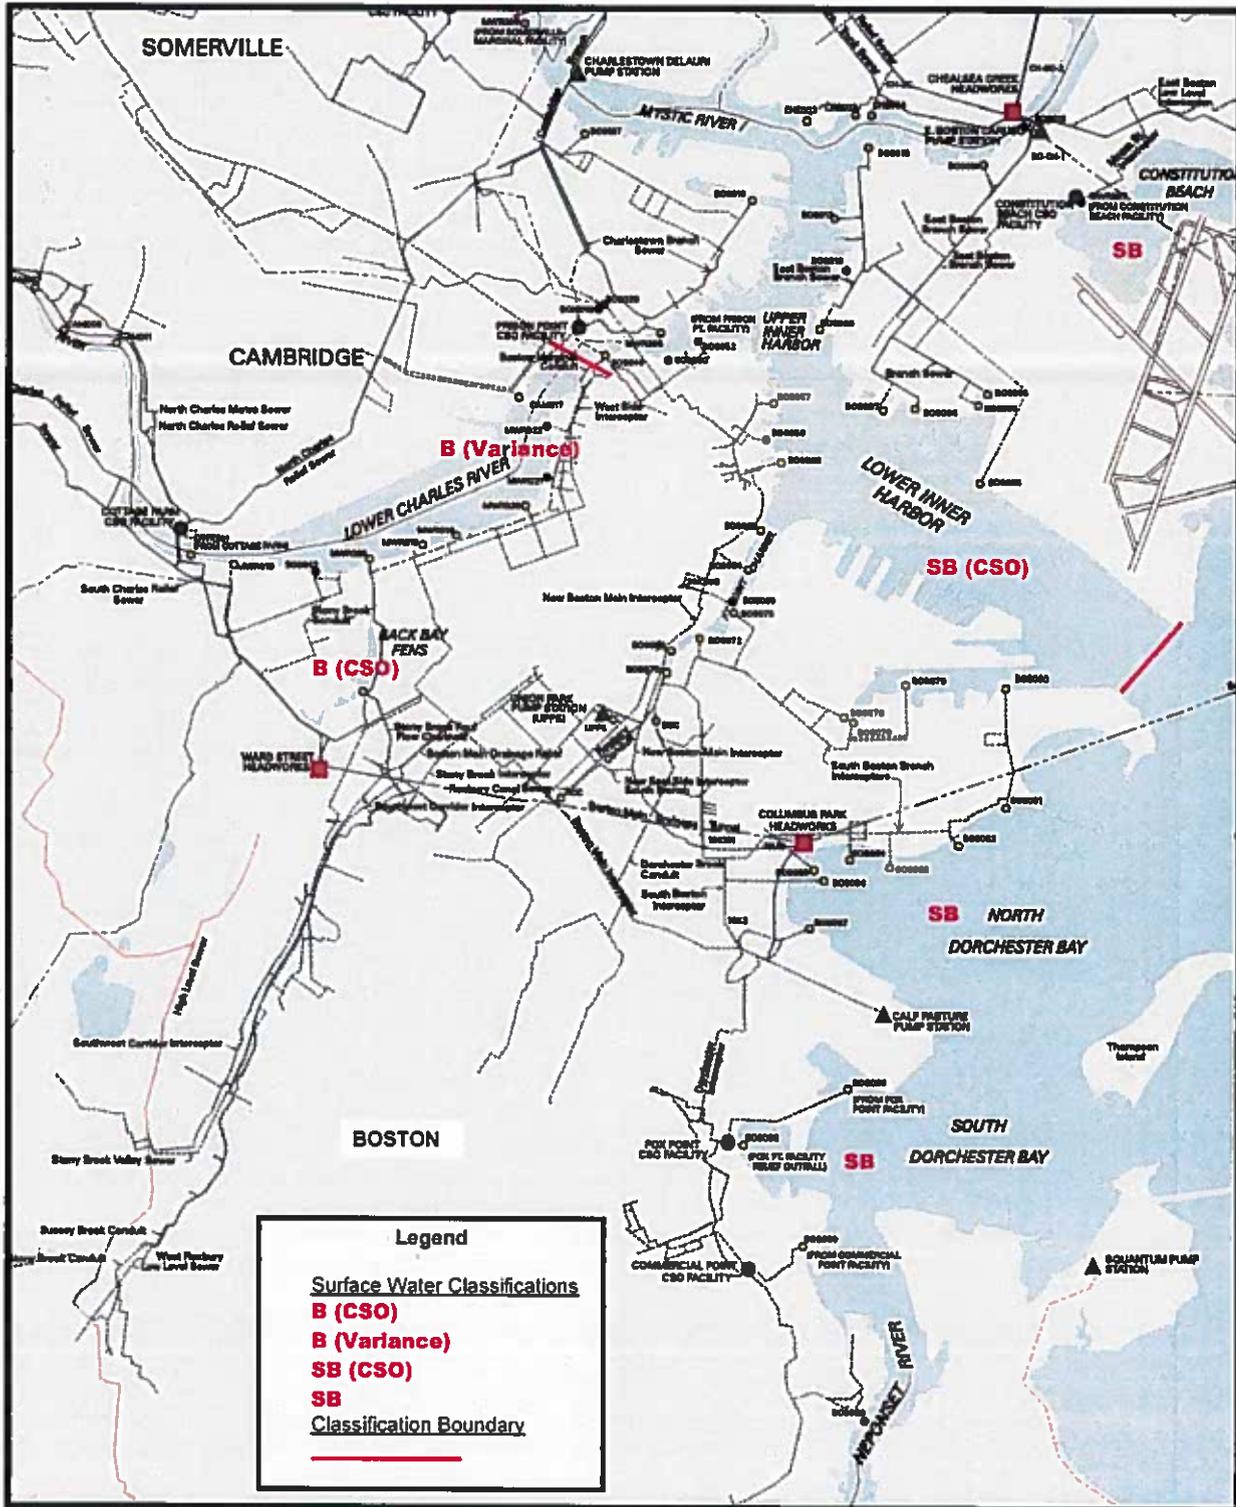
Figure 4: Boston Harbor Drainage System Surface Water Classifications

Figure 4 contains a map of the DEP surface water classifications for Boston Harbor. In addition, Table 10 lists the surface water classifications for Boston Harbor.

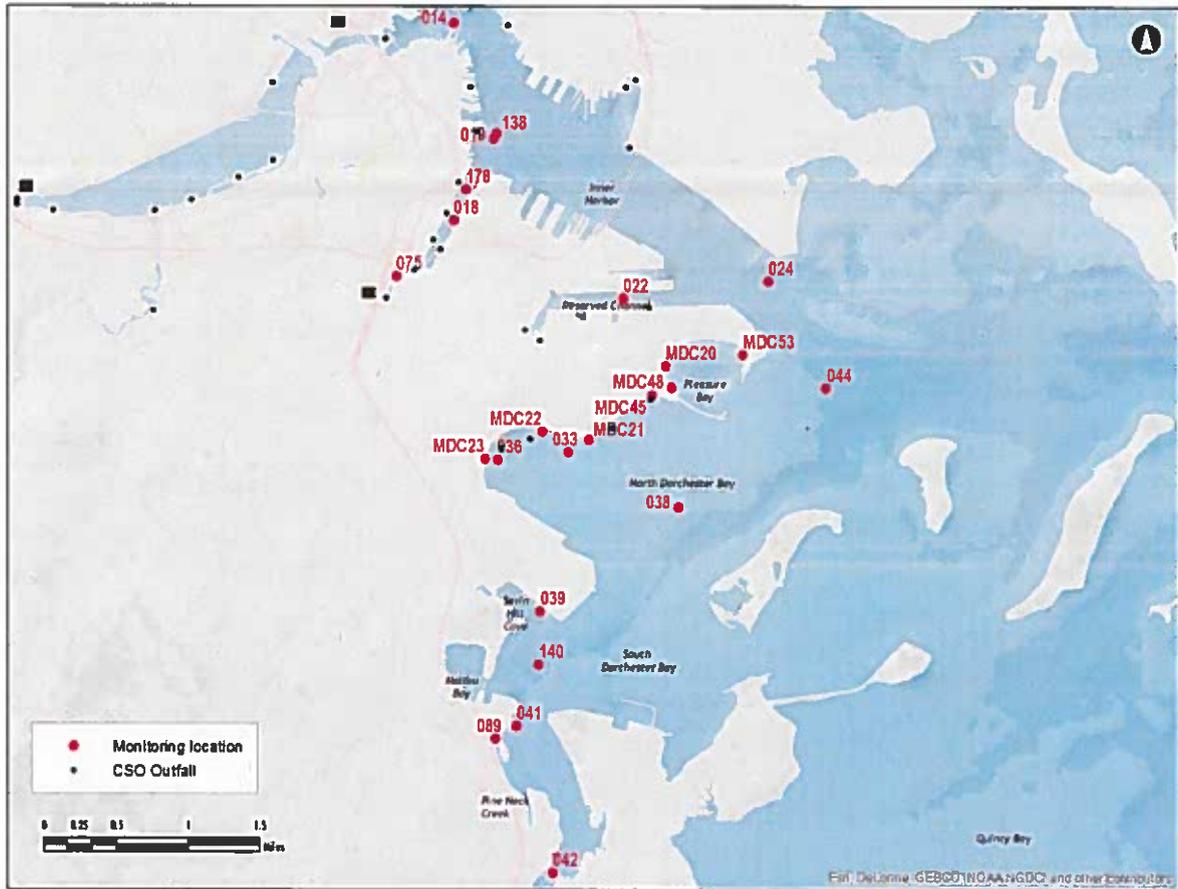
**Figure 5: MWRA and DCR Monitoring Locations in Inner Harbor and Dorchester Bay**

Station 044 is located at the mouth of Dorchester Bay off Castle Island. Station 140 is located near the mouth of Malibu Bay.

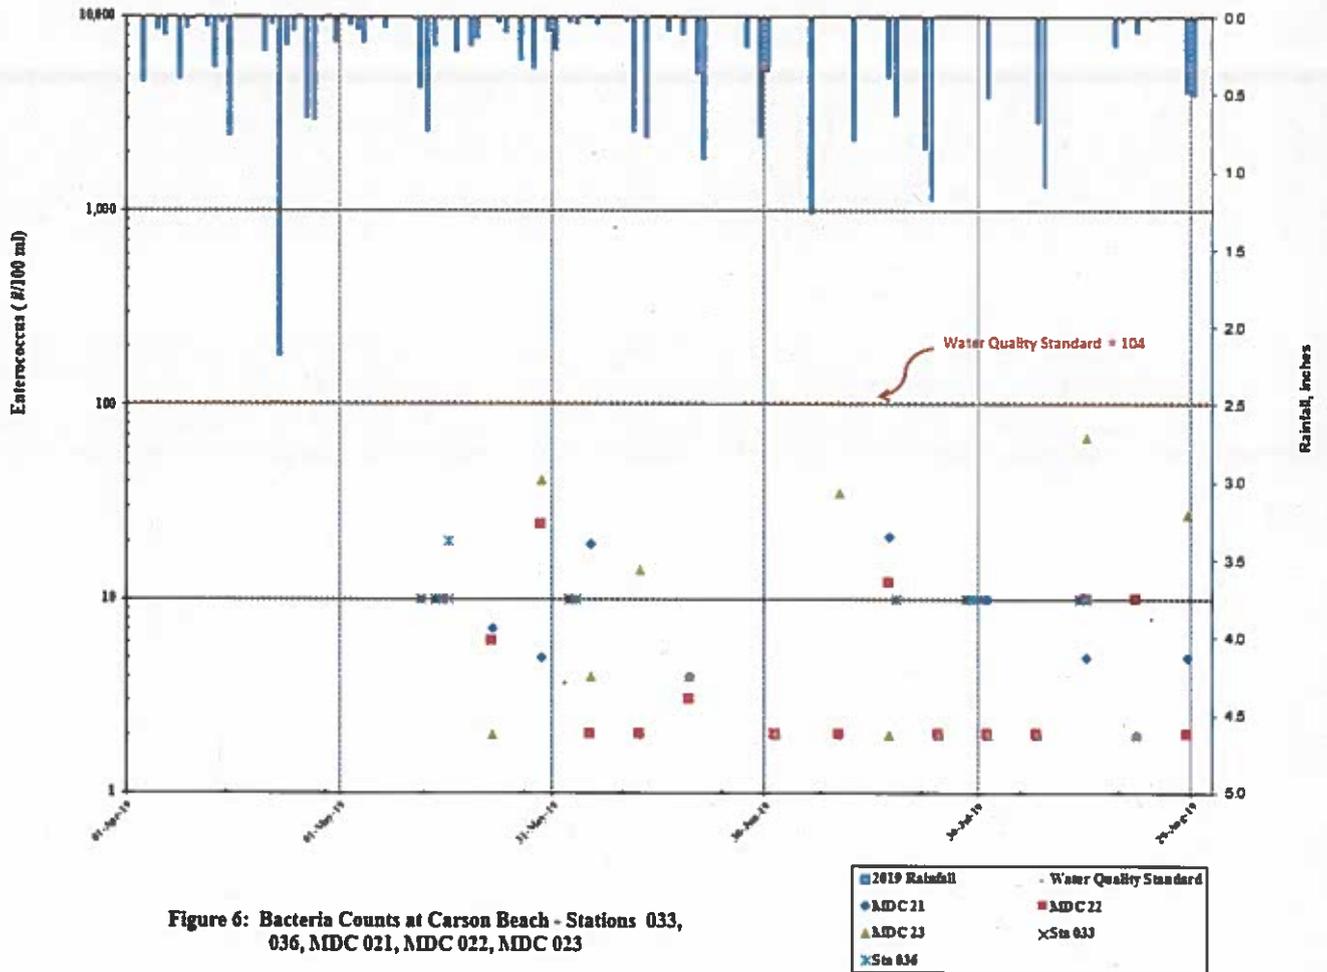
**Enterococcus Levels in Carson Beach - Nearfield Stations MDC 21, MDC 22, MDC 23, and MWRA Fairfield Stations 033 and 036**  
from April 2019 to September 2019

**Figure 6: Bacteria Counts at Carson Beach - Stations 033, 036, MDC 021, MDC 022, MDC 023**

The Water Quality Standard was not exceeded during 2019.

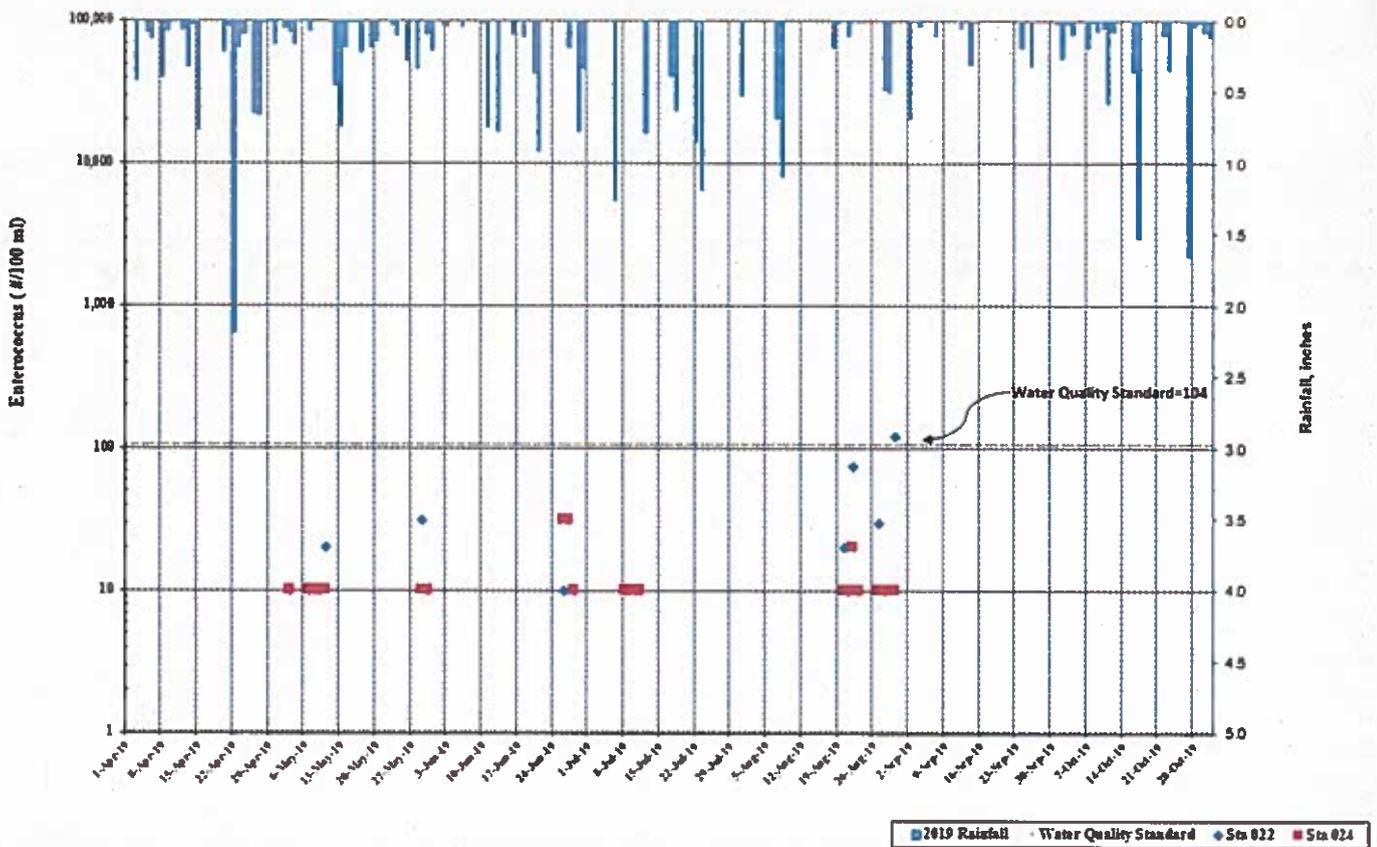
**Enterococcus Levels in Reserved Channel**  
Nearfield Station 022 and Farfield Station 024  
from April 2019 to October 2019

Figure 7: Bacteria Levels in Reserved Channel

In the Reserved Channel, the only sample showing bacteria levels over the *Enterococcus* standard was collected after a rain event in August at Station 22 which is in the middle of Reserved Channel. The areas tributary to Reserved Channel was separated a few years ago although regulators exist on four CSO outfalls. The Commission's NPDES Permit allows these four CSO outfalls to discharge in wet weather. The source of this bacterial contamination could have been these outfalls or the discharges from storm drains.

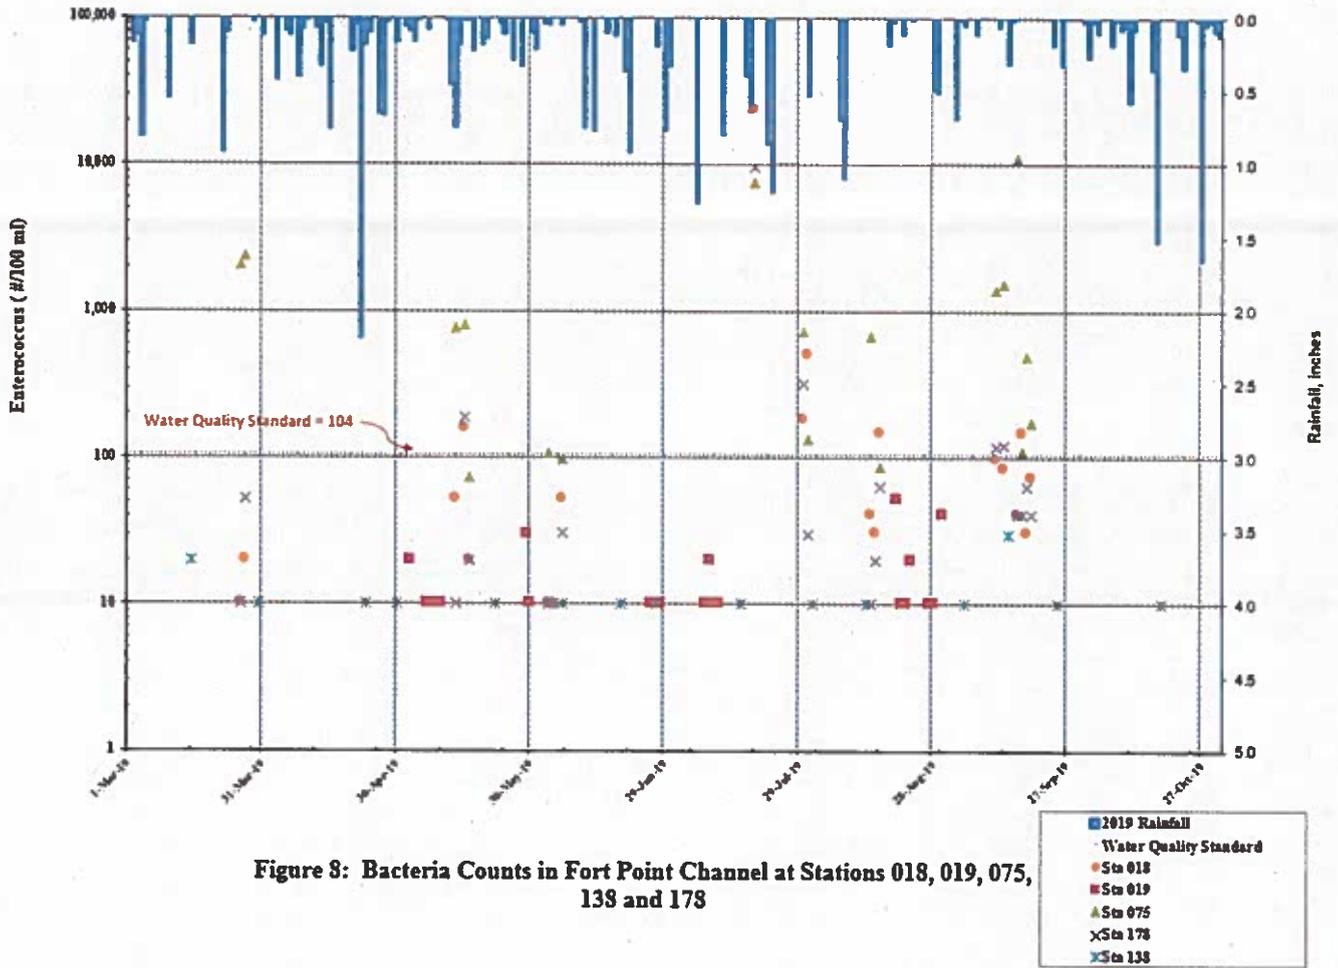
**Enterococcus Levels in Fort Point Channel - Stations 018, 019, 075, 138 and 178**  
 from March 2019 to October 2019

**Figure 8: Bacteria Counts in Fort Point Channel at Stations 018, 019, 075, 138 and 178**

A plot of *Enterococcus* bacteria counts is shown on Figure 8. Union Park discharged four times during this monitoring period. It does not appear that these discharges affect bacterial levels, *Enterococcus* values were high without any of these discharges.
