# **Boston Water and Sewer Commission**

## **CSO Monitoring Report 2021**

**April 2022**

**Boston Water and Sewer Commission**  
**CSO Monitoring Report**  
**For the period from January 1 to December 31, 2021**

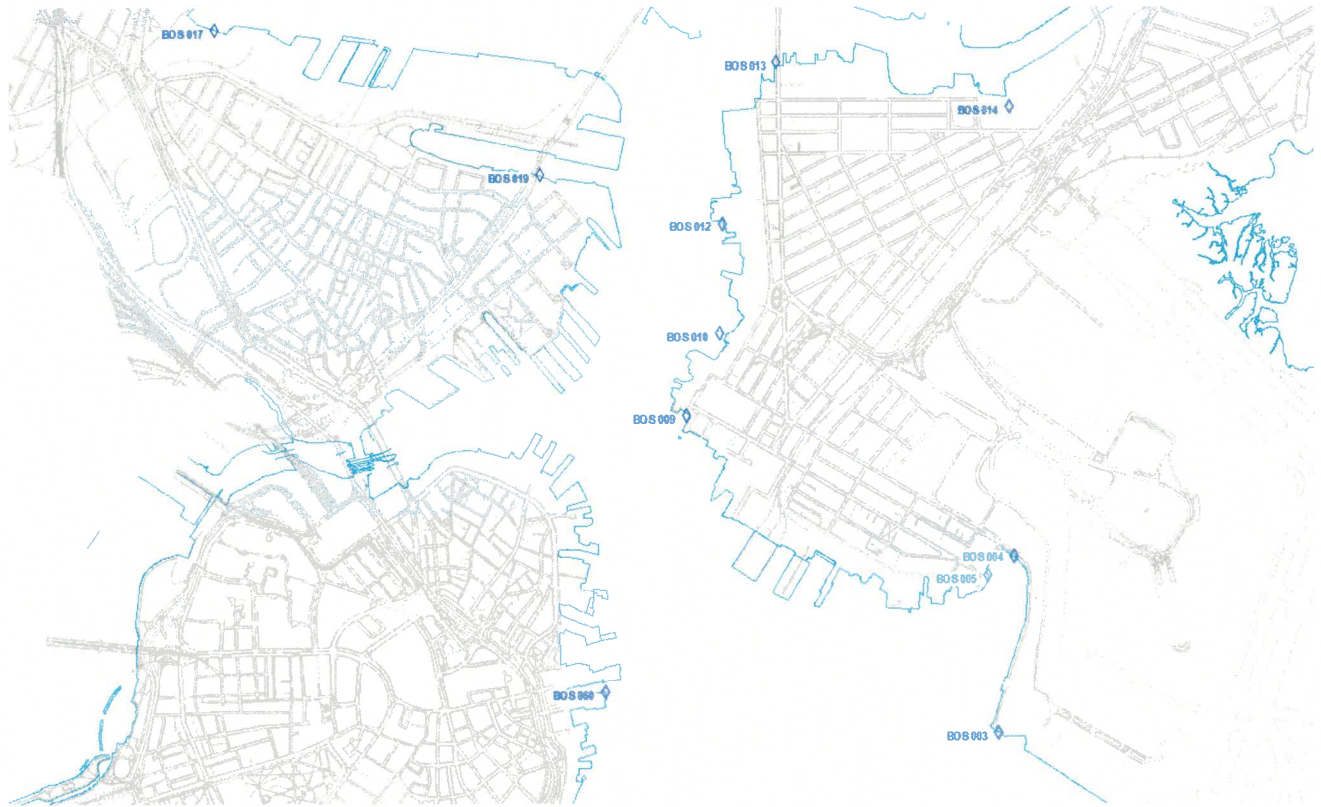
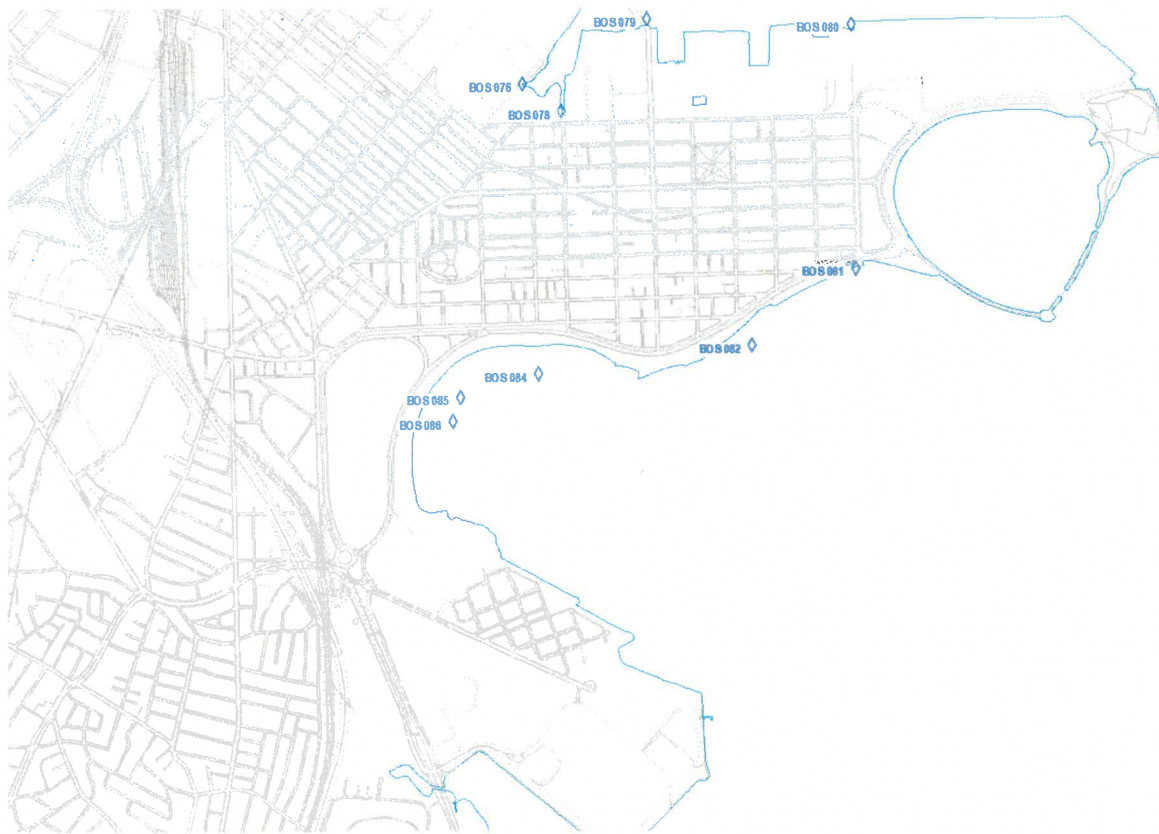
**Figure 1A: CSO Outfalls 2021**

The 37 permitted CSO outfall locations are shown in Figures 1A, 1B and 1C. These locations are also listed in Table 1. Eight (8) of these CSOs are inactive or unable to discharge. BOS 083, included in this group, was routed by the MWRA as part of their North Dorchester Bay CSO Storage Tunnel project (NDB Tunnel). The remaining 29 CSOs are active and can discharge into Boston Harbor, NDB Tunnel or the Muddy River. Five (5) of these CSOs are upstream of the MWRA's NDB Tunnel which discharges only during very large storms, a 25-year storm or larger.

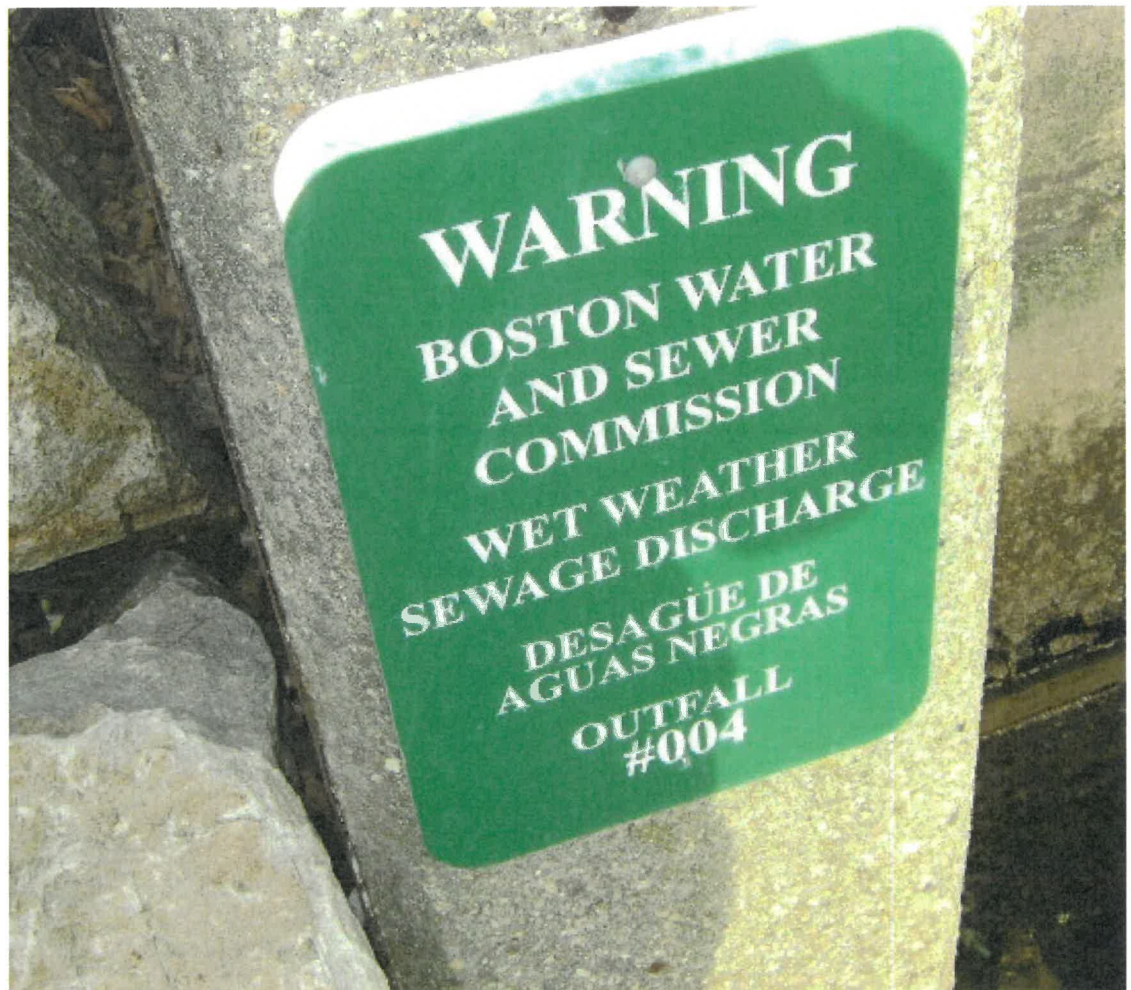
**Figure 2: Example of a sign identifying a CSO**

In compliance with the Nine Minimum Controls, the Commission maintains signs that indicate CSO outfalls and keeps the community abreast of its sewer management actions. An example of a sign identifying outfall BOS 004 in East Boston is shown in Figure 2.

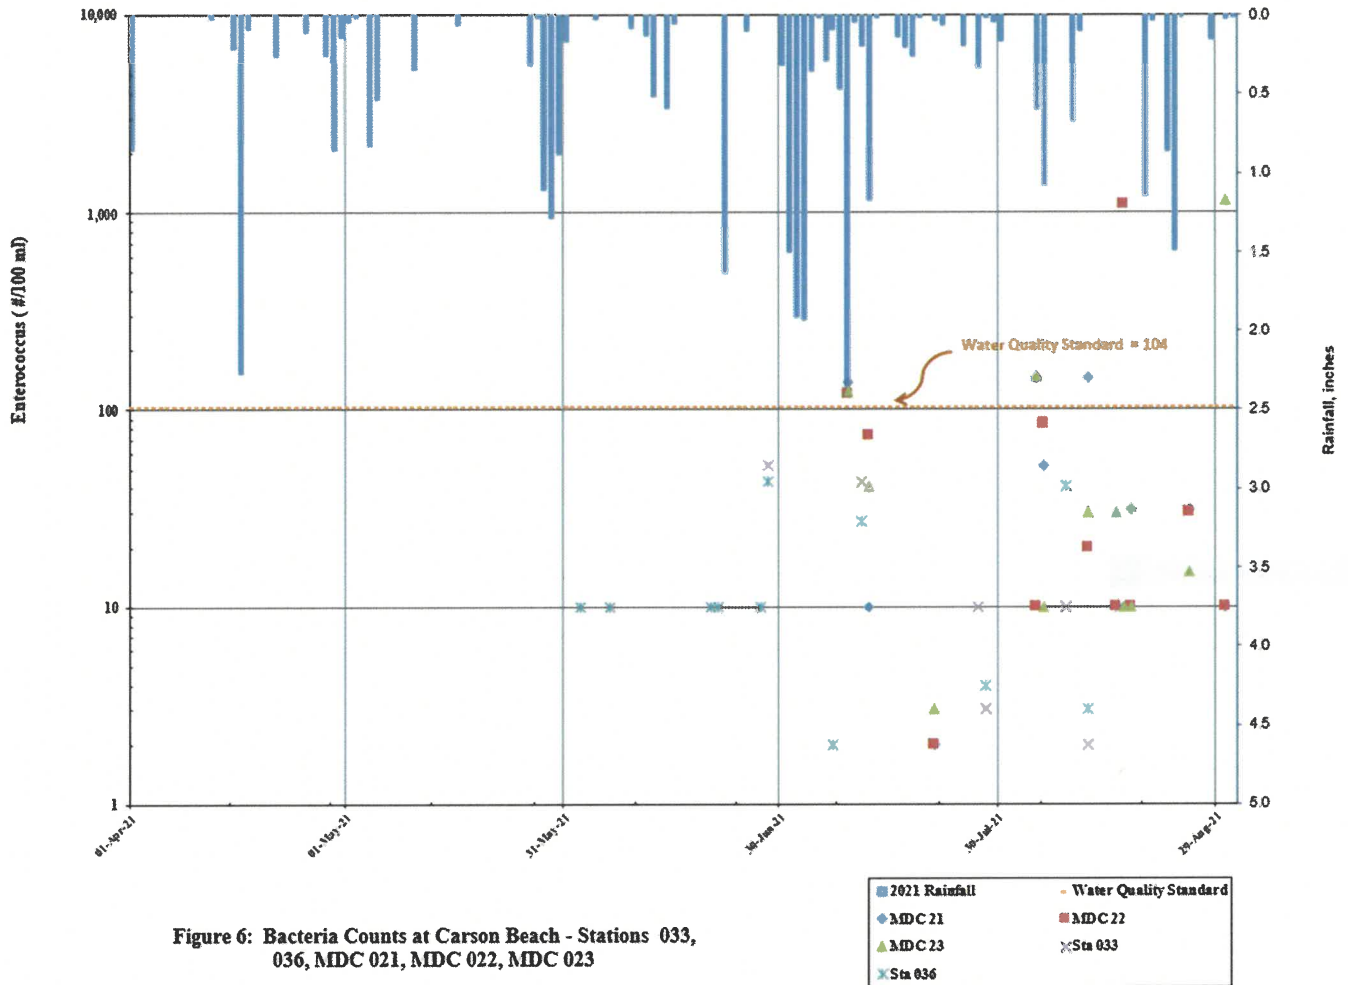
**Figure 6: Bacteria Counts at Carson Beach - Stations 033, 036, MDC 021, MDC 022, MDC 023**

The Water Quality Standard was exceeded six times during 2021.

**Enterococcus Levels in Carson Beach - Nearfield Stations MDC 21, MDC 22, MDC 23, and MWRA Farfield Stations 033 and 036**  
from April 2021 to September 2021

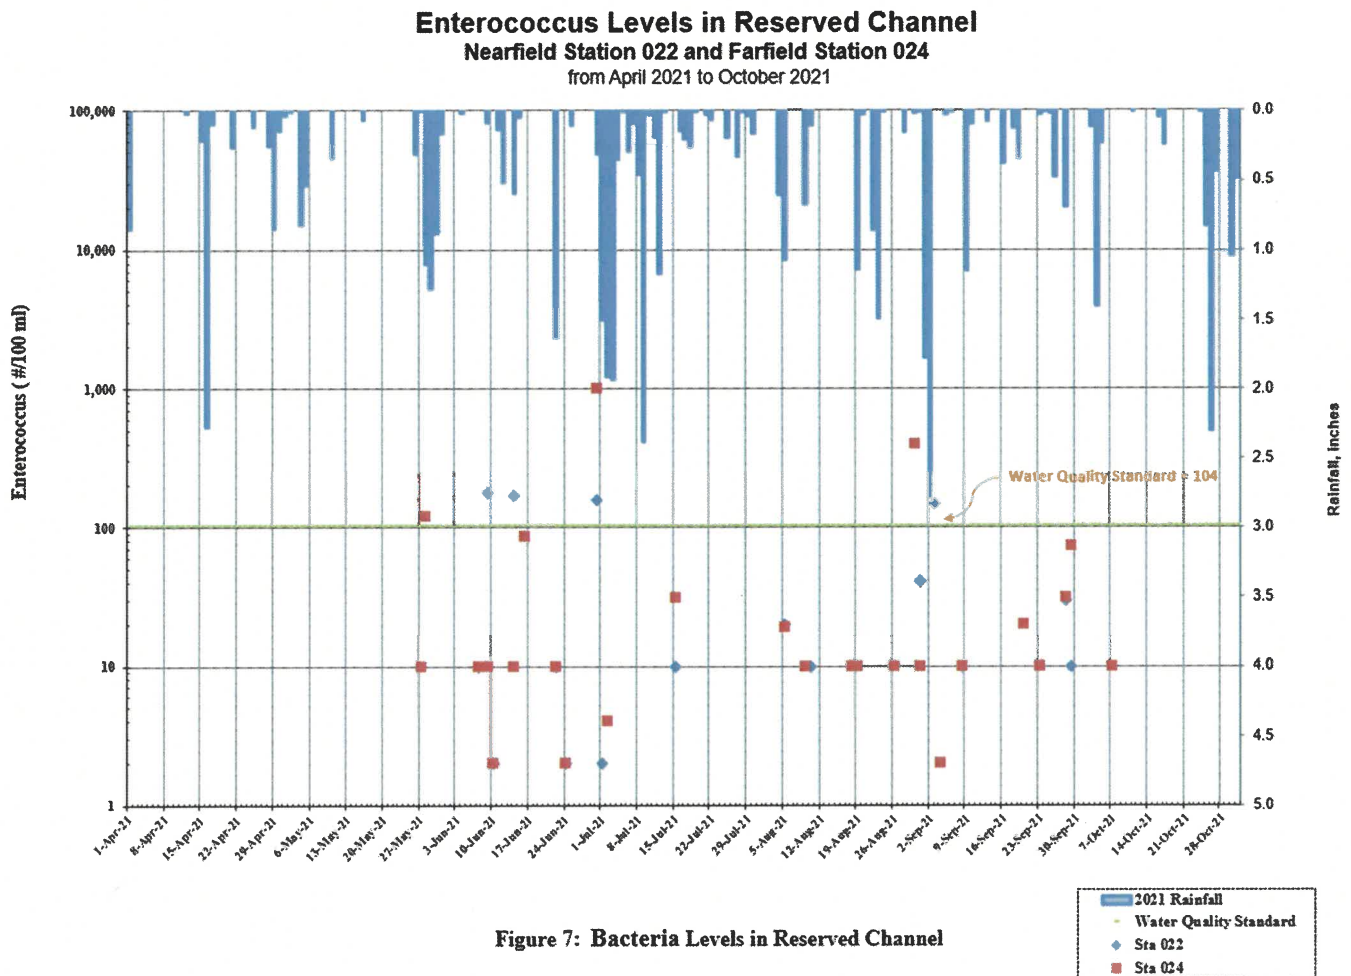
In the Reserved Channel, there were seven samples showing bacteria levels over the *Enterococcus* standard. The areas tributary to Reserved Channel were separated a few years ago although regulators exist on four CSO outfalls. The Commission’s NPDES Permit allows these four CSO outfalls to discharge in wet weather. The source of the bacterial contamination could have been these outfalls or the discharges from storm drains.

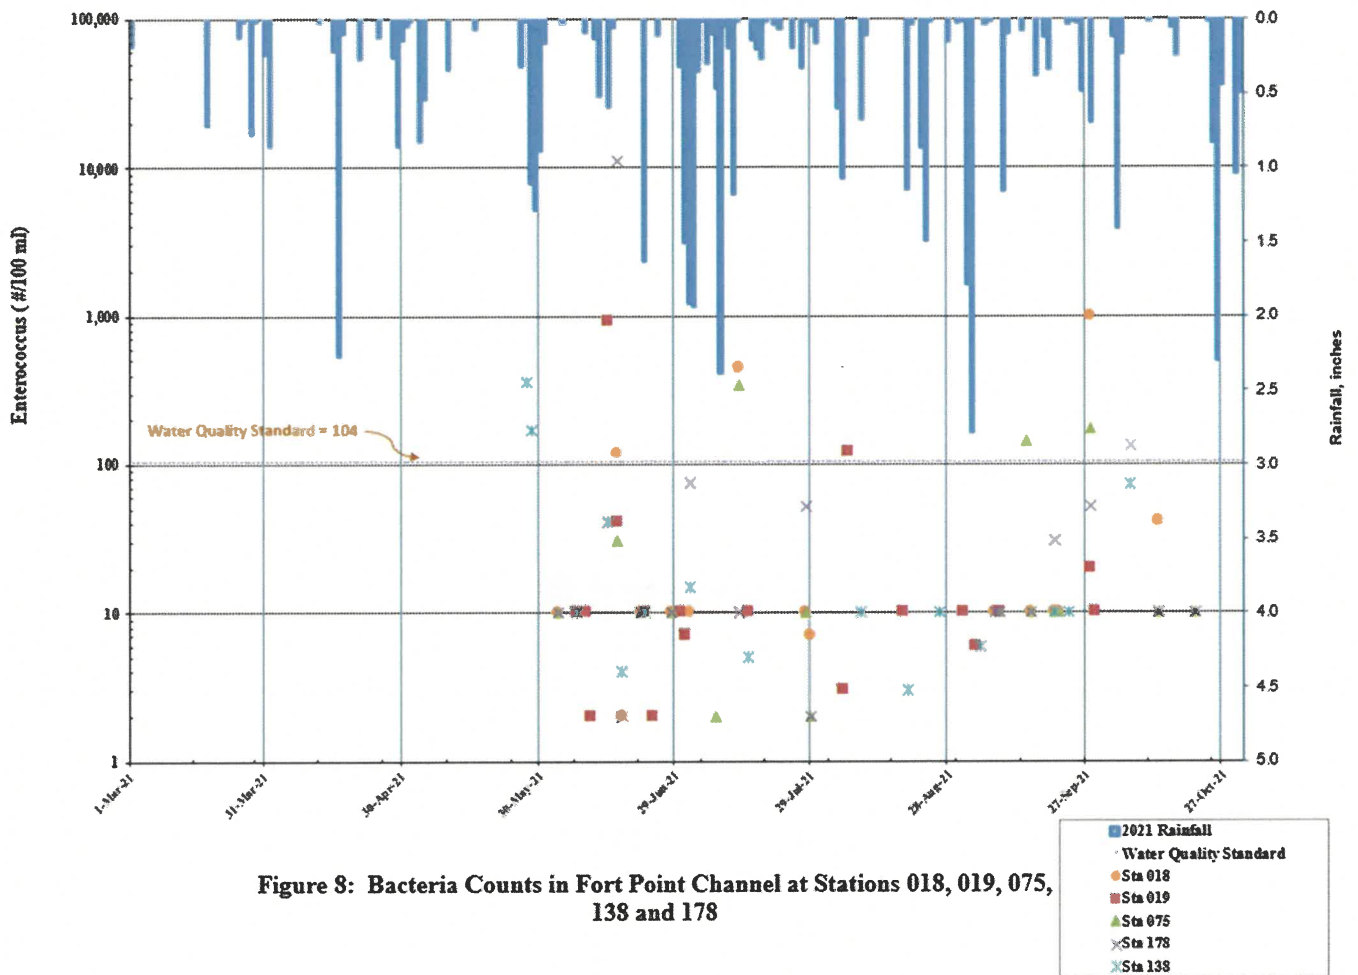
**Figure 8: Bacteria Counts in Fort Point Channel at Stations 018, 019, 075, 138 and 178**

Although Fort Point Channel is not used for swimming, high bacterial counts are a concern and were measured frequently. Of the 108 samples collected, 12 were higher than 104/100 ml. At Station 075 near the BOS 070 outfall, 3 out of the 20 samples were above 104/100 ml. Water quality improved as the sample locations moved further away. Station 178 recorded 2 out of 21 samples above 104/100 ml.

A plot of *Enterococcus* bacteria counts is shown on Figure 8.

**Enterococcus Levels in Fort Point Channel - Stations 018, 019, 075, 138 and 178**  
 from March 2021 to October 2021

The most active is BOS 070 which discharges flows from the MWRA's CSO Facility at Union Park Pumping Station. It should be noted that Union Park Pumping Station discharges are screened and disinfected prior to discharge into the Roxbury Canal Conduit.
