**BOSTON WATER & SEWER COMMISSION**  
**REHABILITATION OF THE NEW BOSTON MAIN INTERCEPTOR**  
**Contract No. 21-309-005A**  
*Report for January 1 through January 31, 2023*

**PROJECT SUMMARY**

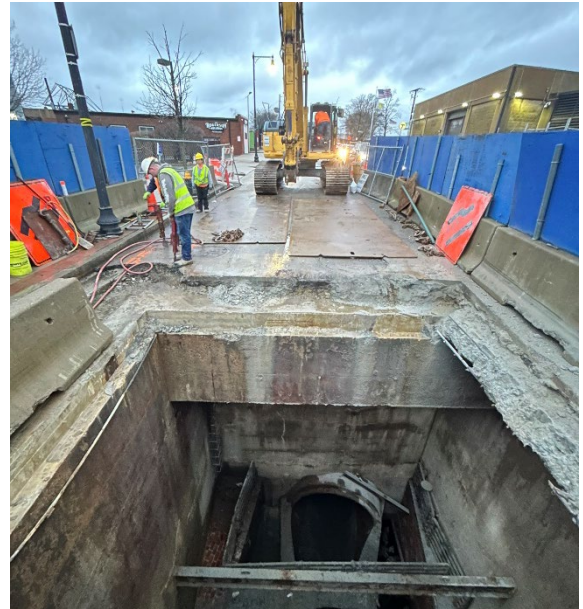
*Inside the work zone on Southamptom Street*

Set up a work zone that will be permanent for several months, with traffic maintained in both directions (work zone width was minimized by removing only a portion of the structure roof at a time). Removed existing deteriorated components such as grate walkways, handrails, and ladders. Removed degraded concrete from the interior walls by hydro blasting. Began refurbishing interior brick surfaces.

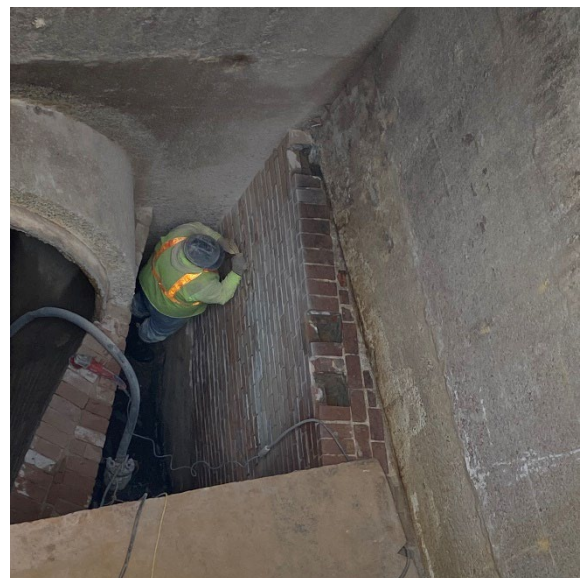
*Refurbishing brickwork in Special Manhole E*
