Boston Water and Sewer Commission

**CSO Monitoring Report
2022**

Boston Water and Sewer Commission
CSO Monitoring Report
For the period from January 1 to December 31, 2022

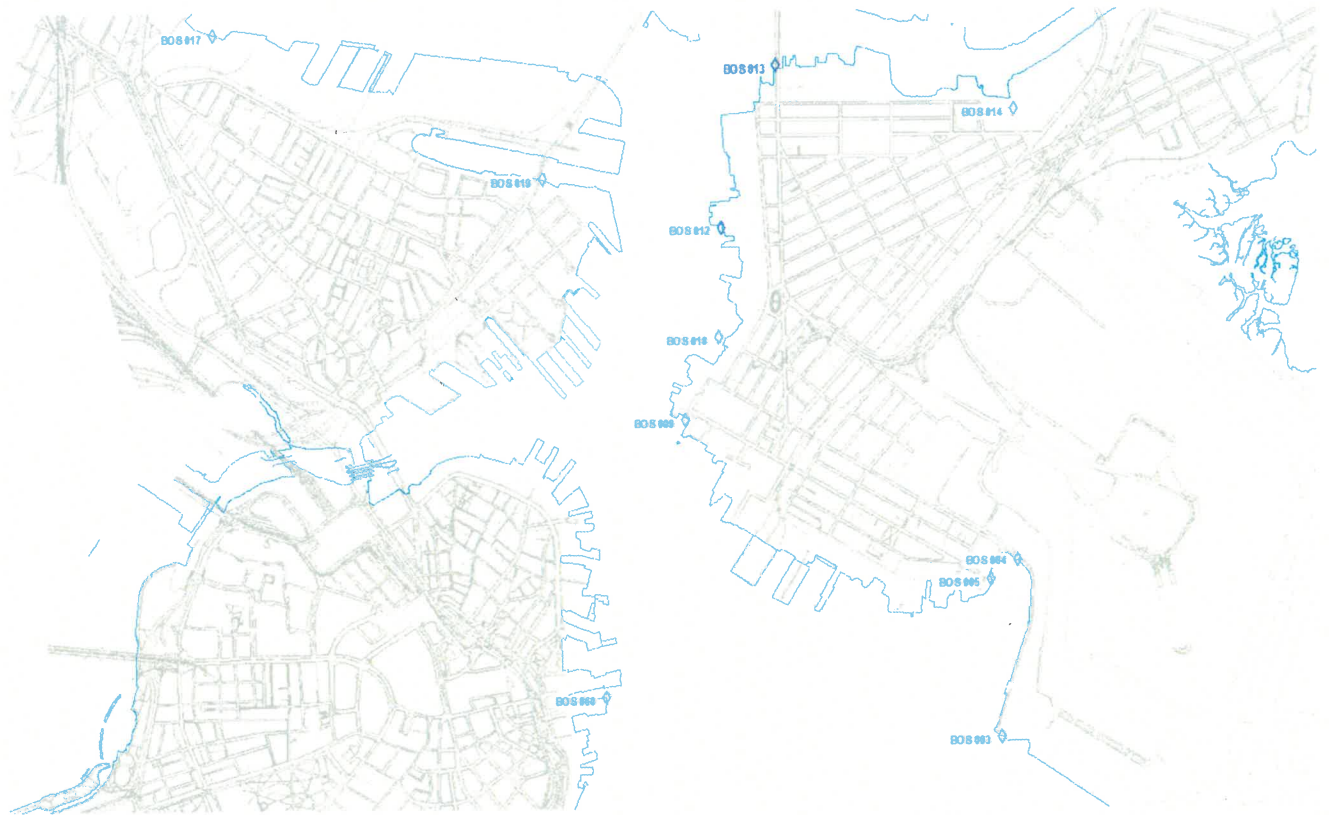
Figure 1A: CSO Outfalls 2022

The 37 permitted CSO outfall locations are shown in Figures 1A, 1B and 1C. These locations are also listed in Table 1. Nine (9) of these CSOs are inactive or unable to discharge. In 2022, BOS 005 was closed during Commission sewer separation in East Boston. BOS 083 was rerouted by the MWRA as part of their North Dorchester Bay CSO Storage Tunnel project (NDB Tunnel). The remaining 28 CSOs are active and can discharge into Boston Harbor, NDB Tunnel or the Muddy River. Five (5) of these CSOs are upstream of the MWRA's NDB Tunnel which discharges only during very large storms, a 25-year storm or larger.

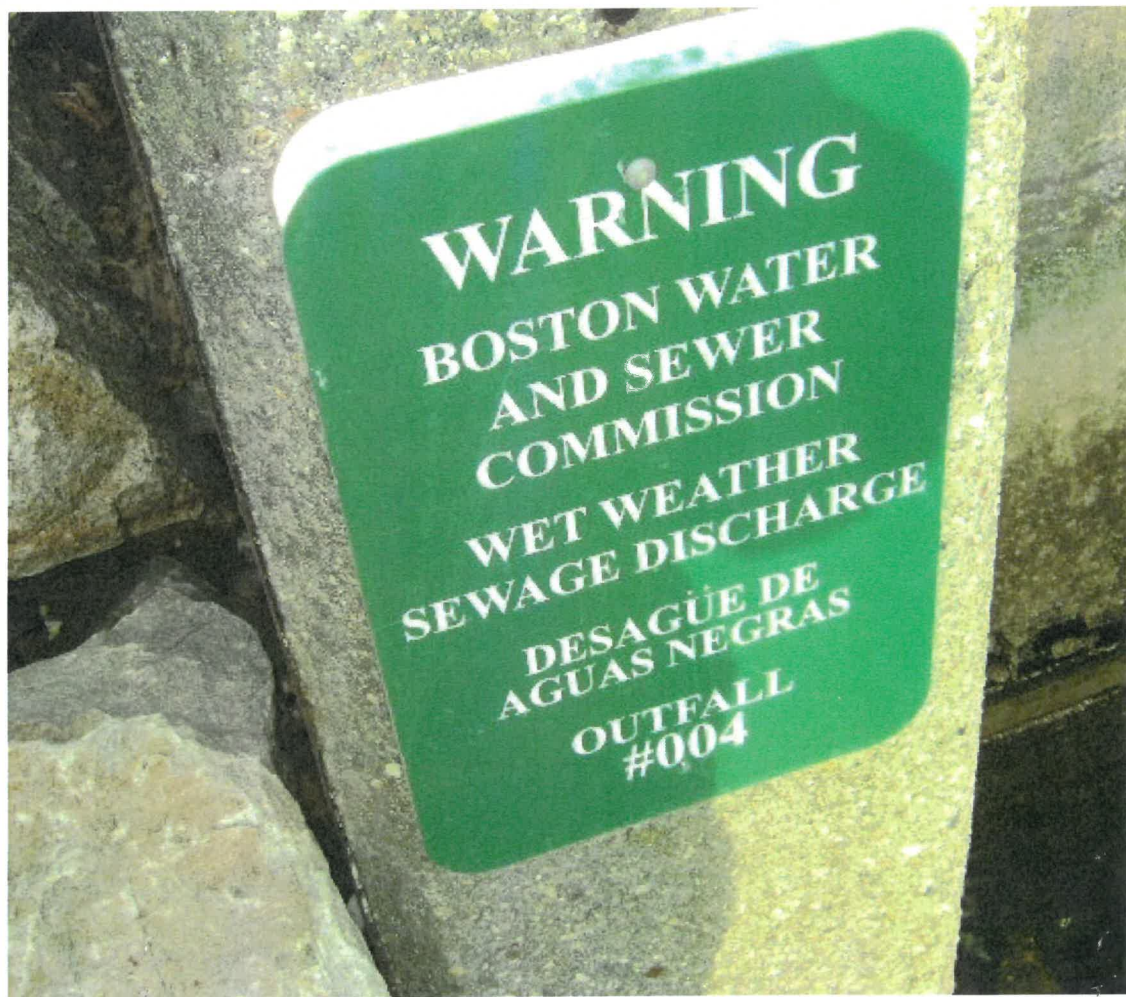
Figure 2: Example of a sign identifying a CSO

In compliance with the Nine Minimum Controls, the Commission maintains signs that indicate CSO outfalls and keeps the community abreast of its sewer management actions. An example of a sign identifying outfall BOS 004 in East Boston is shown in Figure 2.

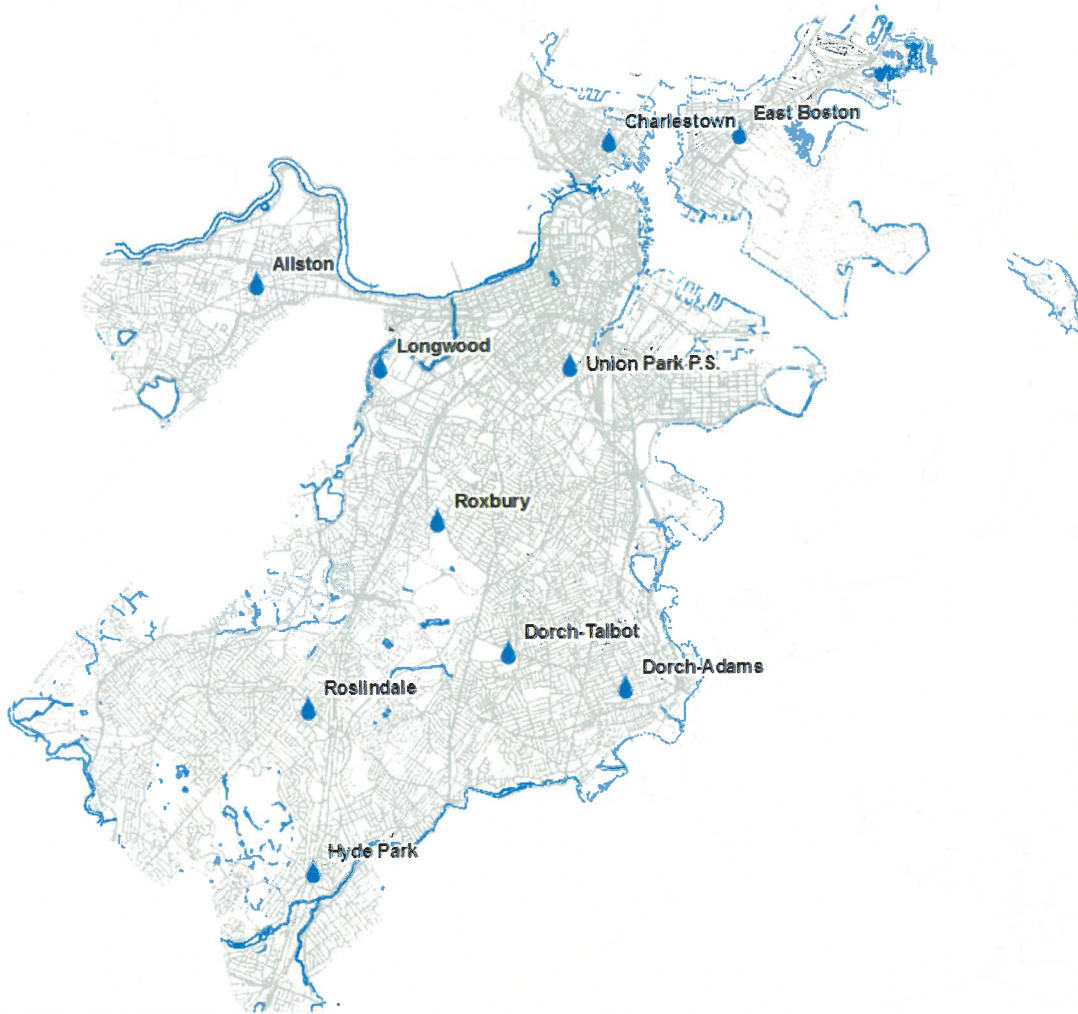
Figure 3 – BWSC Rain Gage Locations

Over the last 10 years, patterns exist in the rainfall distributions; some locations consistently have more rainfall than others. Generally, the Commission's gages record more rainfall than Logan Airport. The Commission's ten rain gages are shown on Figure 3 on the following page.

For a number of years, the Commission collected rainfall from eight rain gages located on the rooftops of public buildings; the system has been expanded to ten locations. This rainfall data continues to be available to other agencies and the public on the Commission's web site at <https://www.bwsc.org/environment-education/rainfall-garden.asp>. The gages are located at the following locations:

1. *Union Park Pumping Station, 120 Malden St. in the South End*
2. *Roslindale, Washington Irving Middle School at 105 Cummins Highway*
3. *Dorchester-Adams, Thomas J. Kenny School at 19 Oakton Avenue*
4. *Union Square – Allston, Boston Fire Department at 460 Cambridge St.*
5. *Hyde Park, Boston Police Station at 1243 Hyde Park Ave.*
6. *Dorchester-Talbot, Joseph Lee School at 155 Talbot Ave. in Mattapan*
7. *Charlestown, Harvard Kent School at 50 Bunker Hill St.*
8. *Longwood Medical Area, MASCO Building*
9. *Roxbury, Eggleston Square Branch of Boston Library*
10. *East Boston, East Boston Branch of Boston Library*

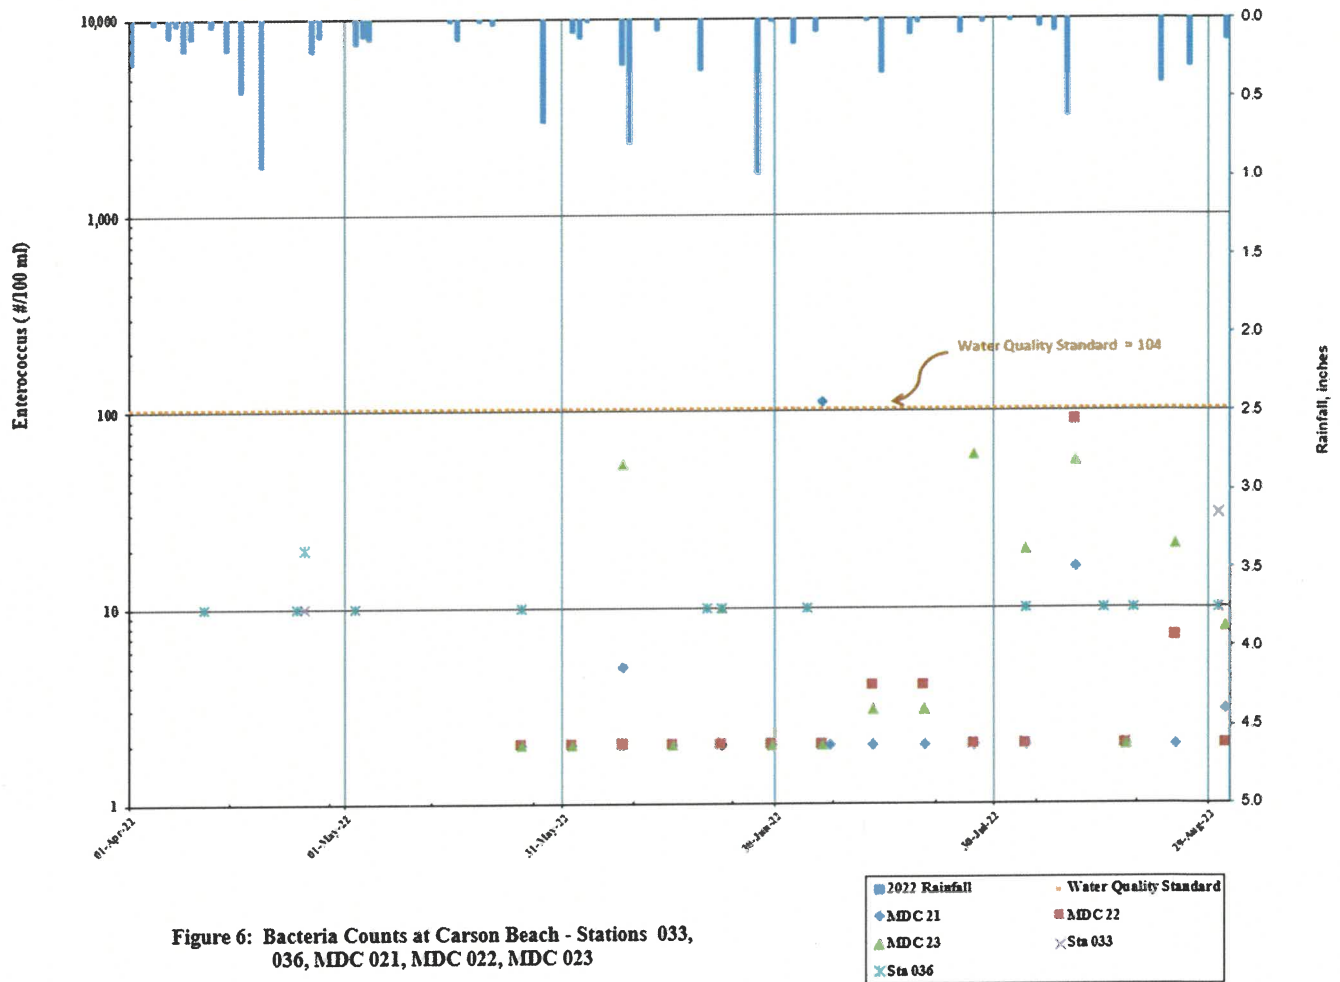
Figure 6: Bacteria Counts at Carson Beach - Stations 033, 036, MDC 021, MDC 022, MDC 023

The Water Quality Standard was exceeded one time during 2022.

Enterococcus Levels in Carson Beach - Nearfield Stations MDC 21, MDC 22, MDC 23, and MWRA Farfield Stations 033 and 036 from April 2022 to September 2022

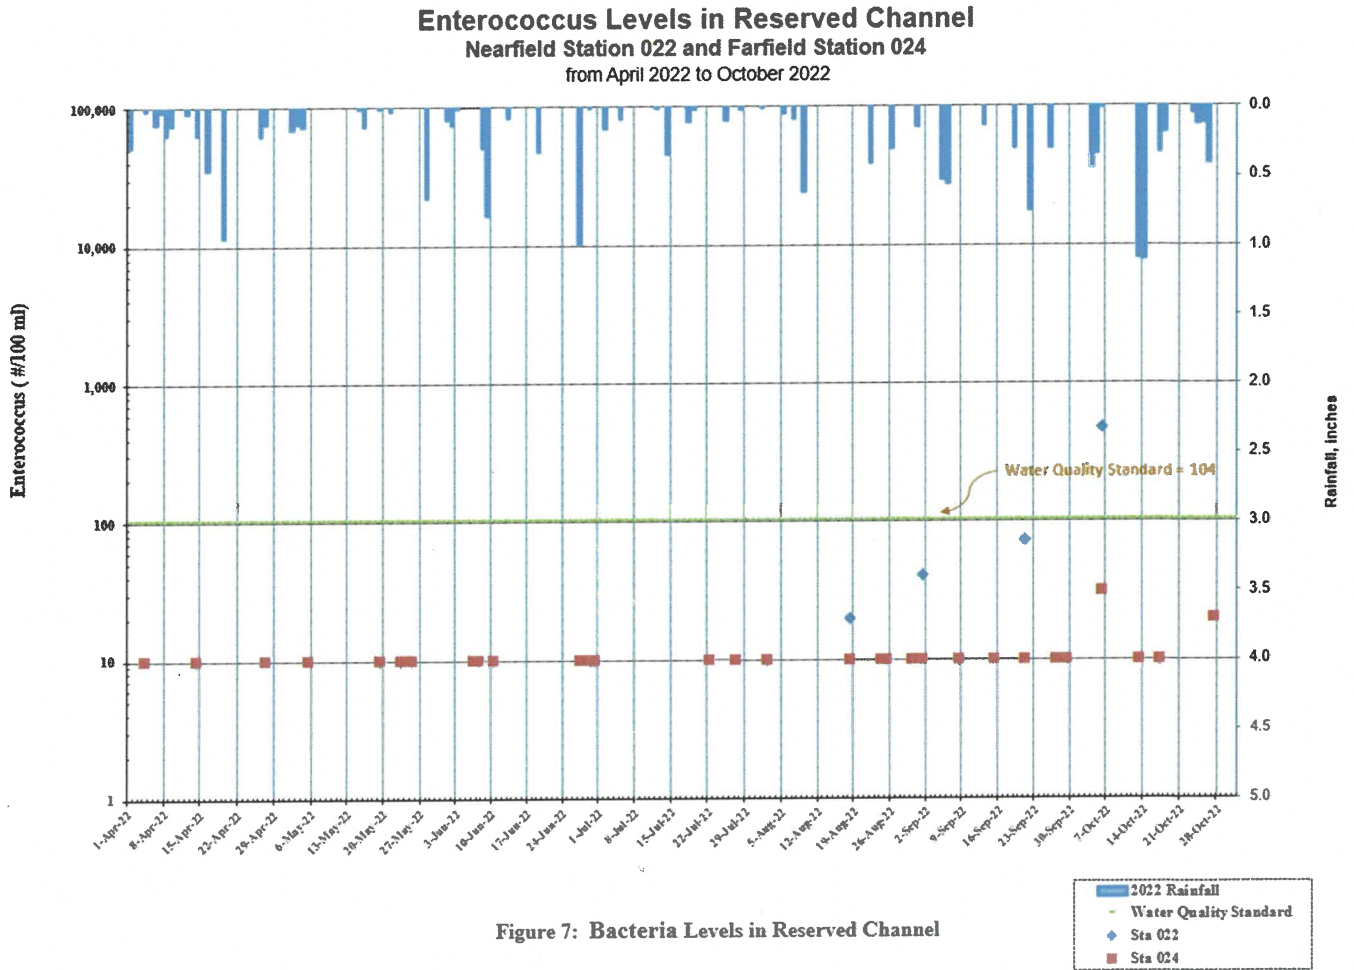
In the Reserved Channel, there was one sample showing bacteria levels over the *Enterococcus* standard. The areas tributary to Reserved Channel were separated a few years ago although regulators exist on four CSO outfalls. The Commission's NPDES Permit allows these four CSO outfalls to discharge in wet weather. The source of the bacterial contamination could have been these outfalls or the discharges from storm drains.
