BOSTON WATER & SEWER COMMISSION
REHABILITATION OF THE NEW BOSTON MAIN INTERCEPTOR
Contract No. 21-309-005A
Report for May 1 through May 31, 2023

PROJECT SUMMARY

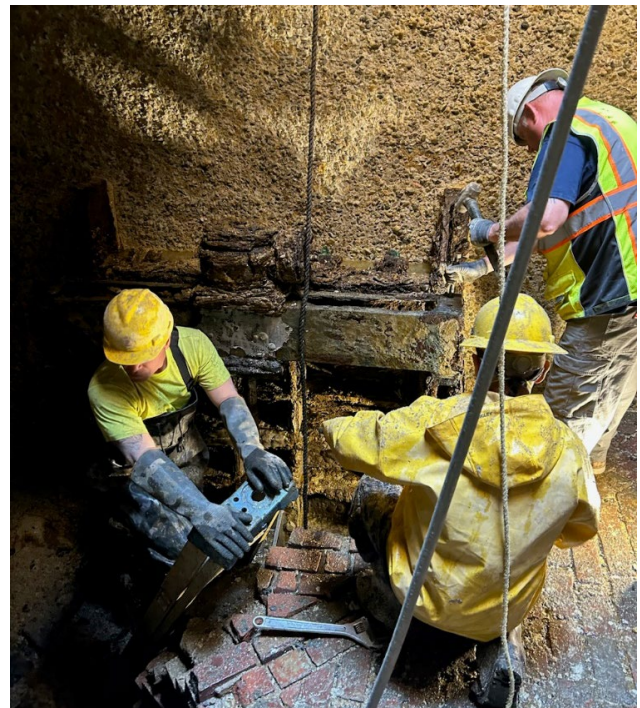
Crews remove old gate in Special Manhole C.

Occupying temporary work zone only during non-peak hours to clean the structure interior and remove existing deteriorated components such as handrails and a gate. Removed degraded concrete from interior walls by hydro blasting. Began demolition of a section of the existing brick shelf.

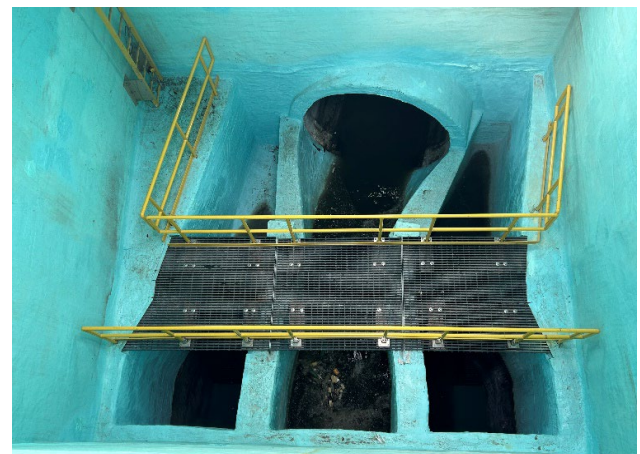
Special Manhole E, rehabilitated with cementitious liner and epoxy coating and ready for safe access.

Repaired/rebuilt concrete walls and refurbished brick surfaces and stop log systems. Rehabilitated surfaces with cementitious spray-on liner and epoxy coating. Replaced grate walkways, handrails, and ladders necessary for safe maintenance.
